## A 20-year anniversary – The loss of lives in lifeboats with on-load release hooks

Lifeboats are designed to save lives, but over the years too many seafarers have died or been seriously injured during routine safety exercises in davit-suspended boats fitted with on-load release hooks. Gard News has a look at the problem.<sup>1</sup>

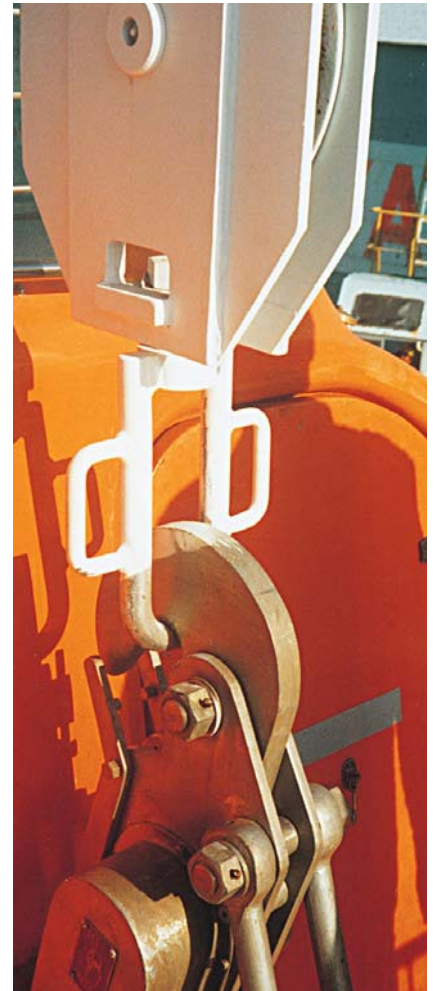
**An on-load release hook, which was brand new and of solid construction when it released accidentally.**

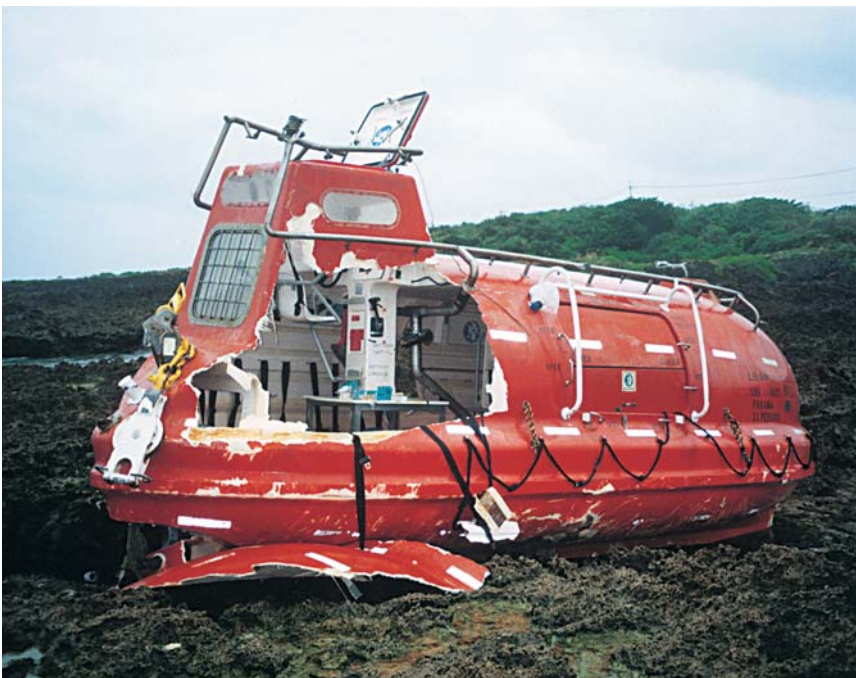
**This lifeboat released itself from a vessel, fortunately without anybody on board. It was found on a coral reef two weeks later.**

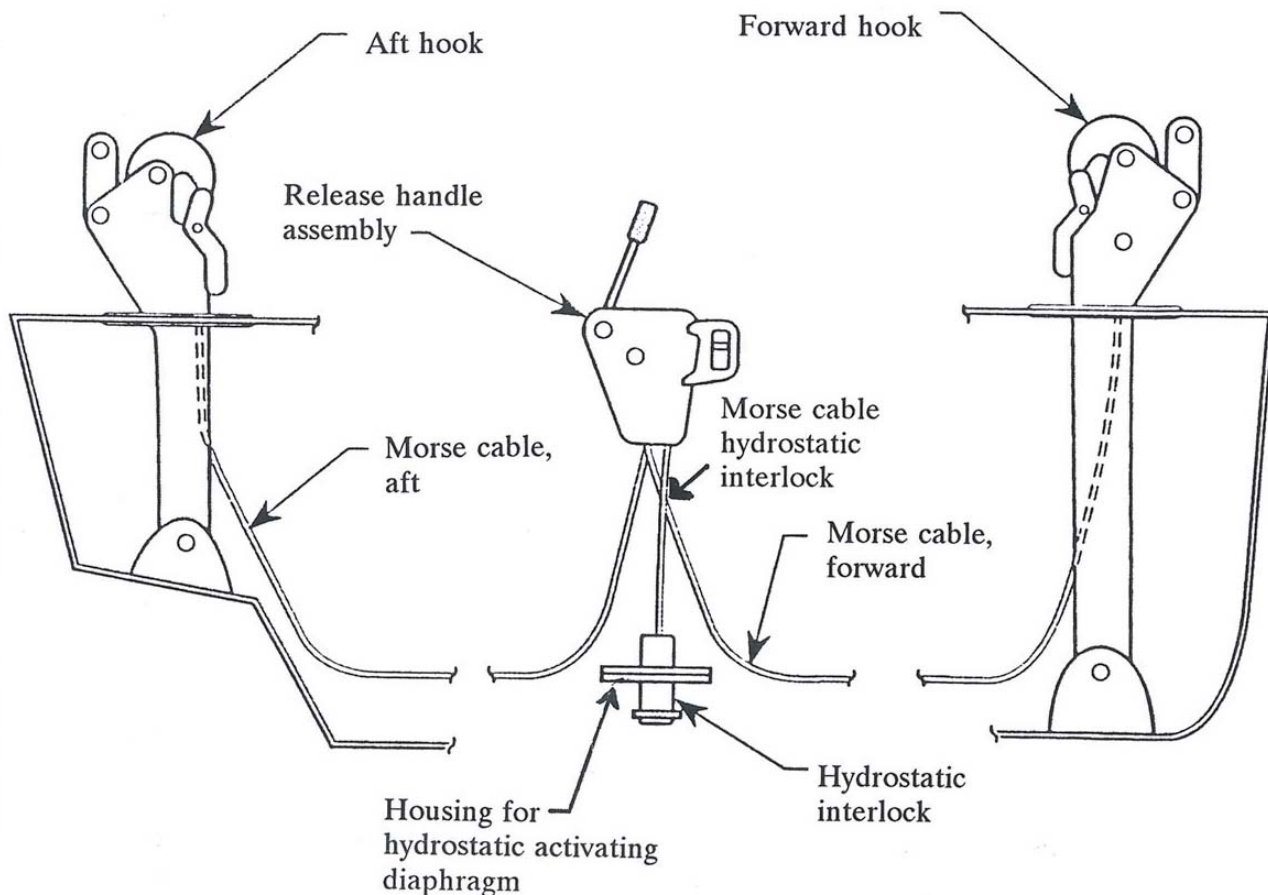
Release mechanism general assembly (courtesy of MAIB).

**During investigation of an incident it became apparent that the safety pin had not been fitted to the release handle and it was suggested that one of the crew members on board might have thought that the handle was the clutch of the lifeboat engine.**
